Newly Planted Street Survey

Assessing the condition of Birmingham's newly planted trees

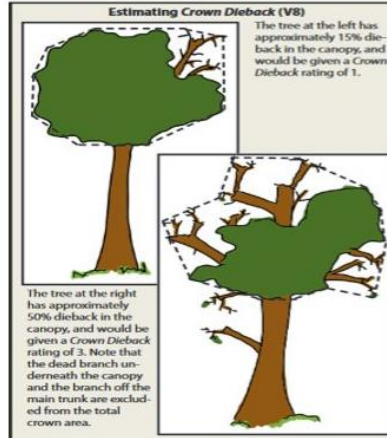
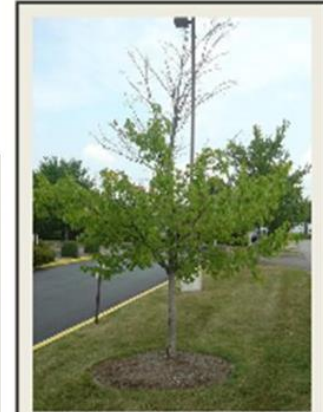
Figure V8. Example of Crown Dieback. A red maple (*Acer rubrum*) exhibiting crown dieback. This tree would receive a Crown Dieback rating of 3, corresponding to 40-60% dieback.

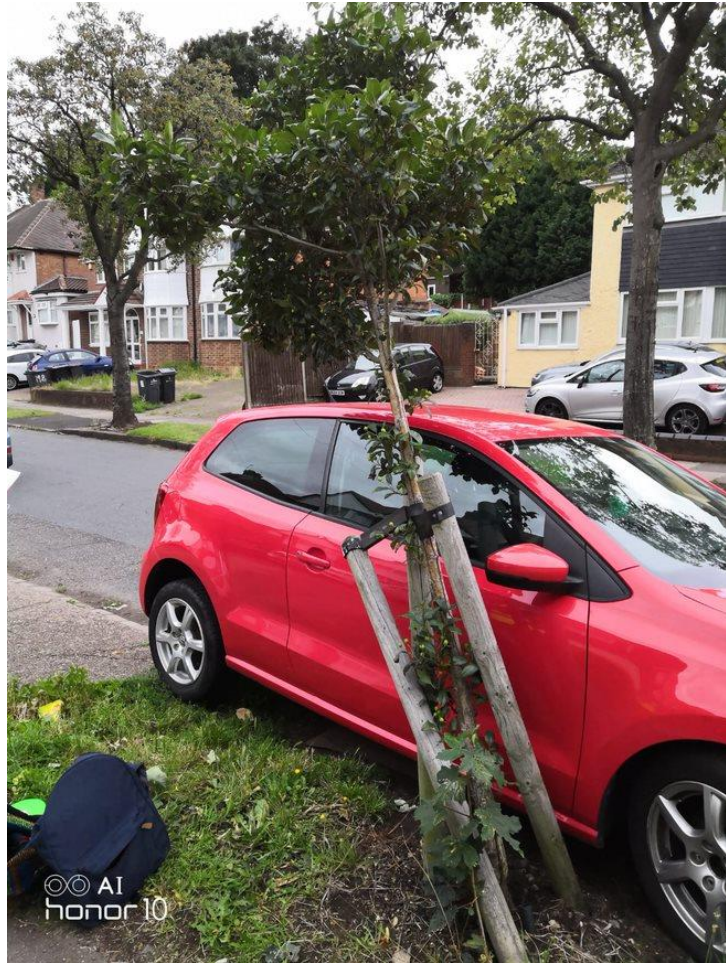
Findings – lower trunk damage

- 23.5% trees with lower trunk damage
- Possible reasons – strimmers/ground maintenance, vehicles, species of tree

Is the damage due to cars parking on the verges/pavements, etc?			
lower trunk damage	177 trees out of 754		23.47%
no parking allowed	19	major shortage	16
easy parking	57	clear shortage	5
free flowing parking	28	limited parking	48
	104		69
	173	60.12%	39.88%

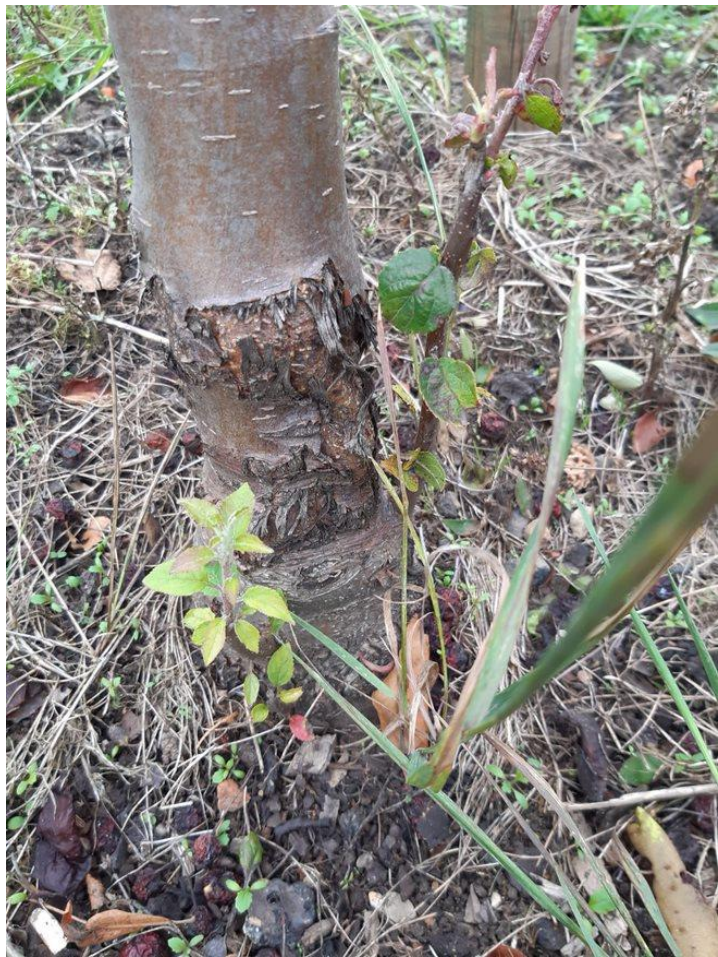
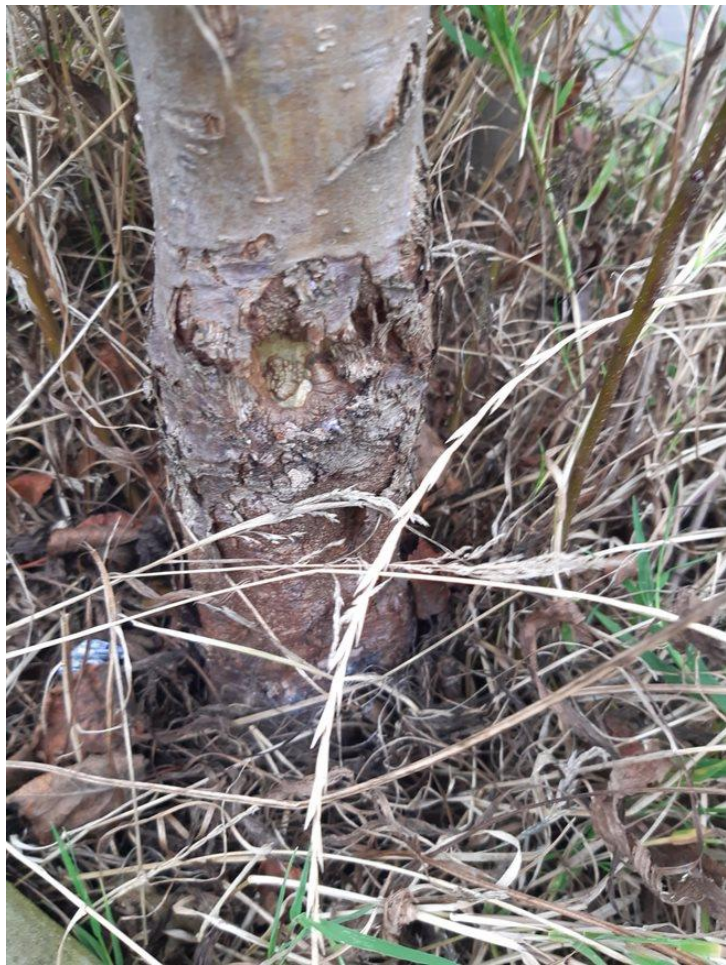
Findings – lower trunk damage

- These are the species that are overrepresented with lower trunk damage

No. trunk damage	% damage	% pop	diff
Prunus	12	12.24%	2.25%	9.99%
Malus	10	10.20%	7.03%	3.17%
Corylus colurna	11	11.22%	4.91%	6.31%
Crataegus laevigata	5	5.10%	1.99%	3.11%

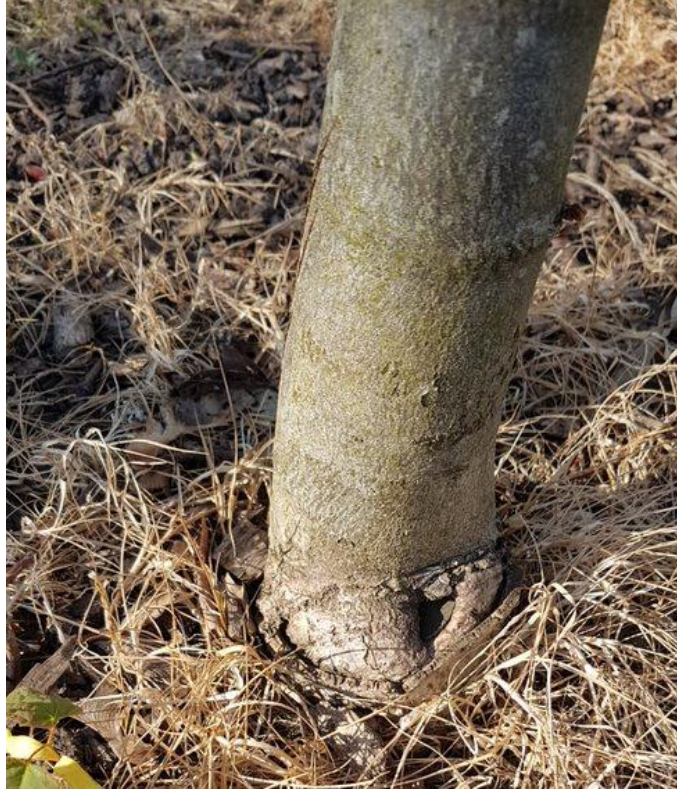
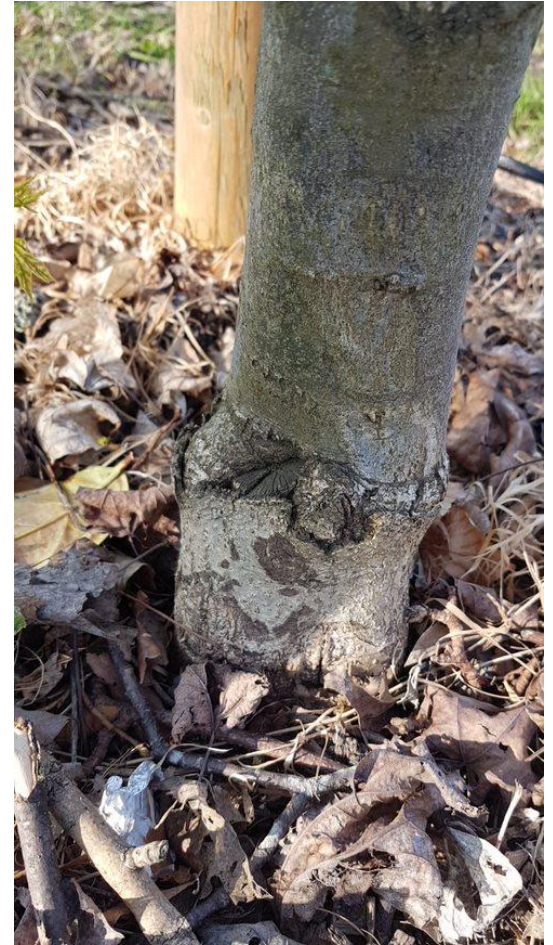
Findings – root problems

- Failed grafts on *Tilia tomentosa* 'Brabant'

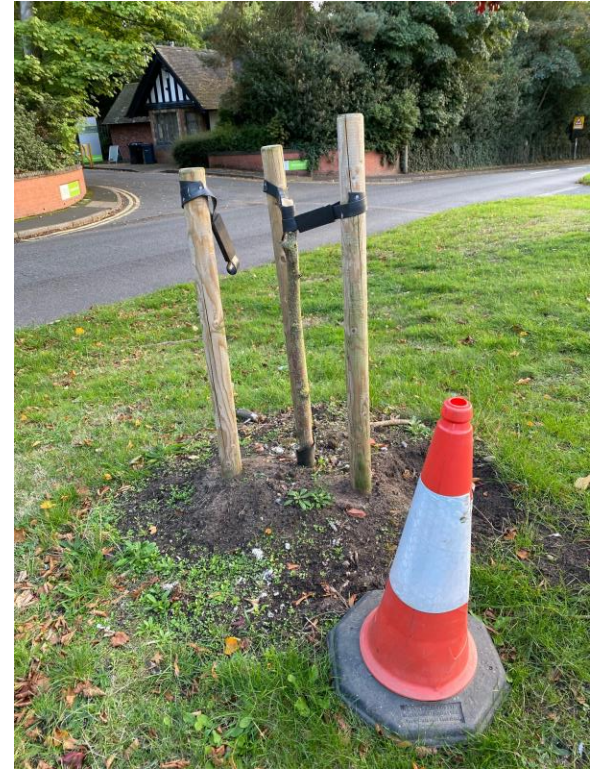
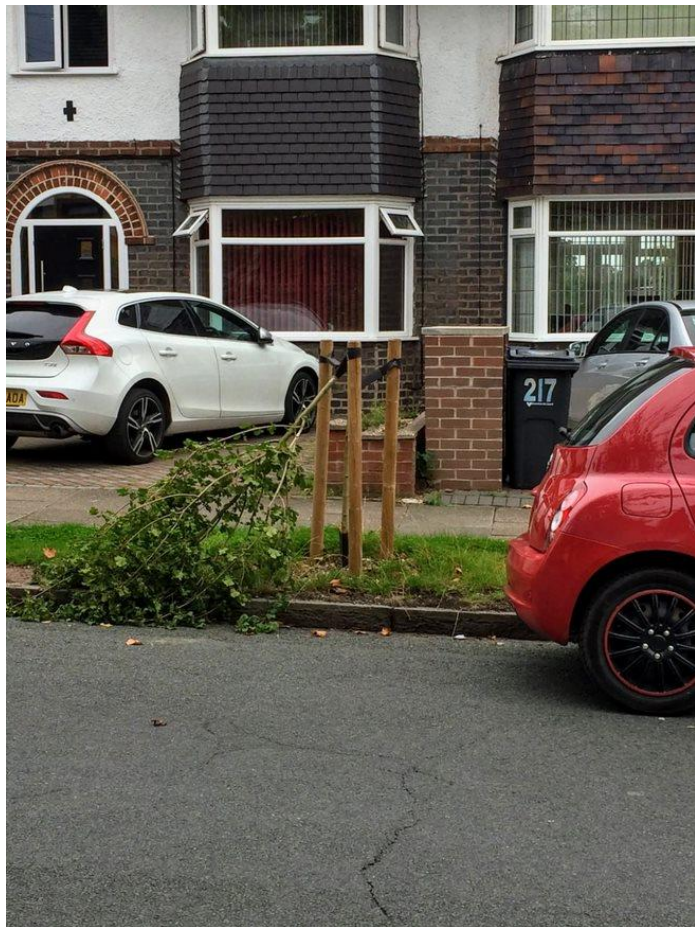
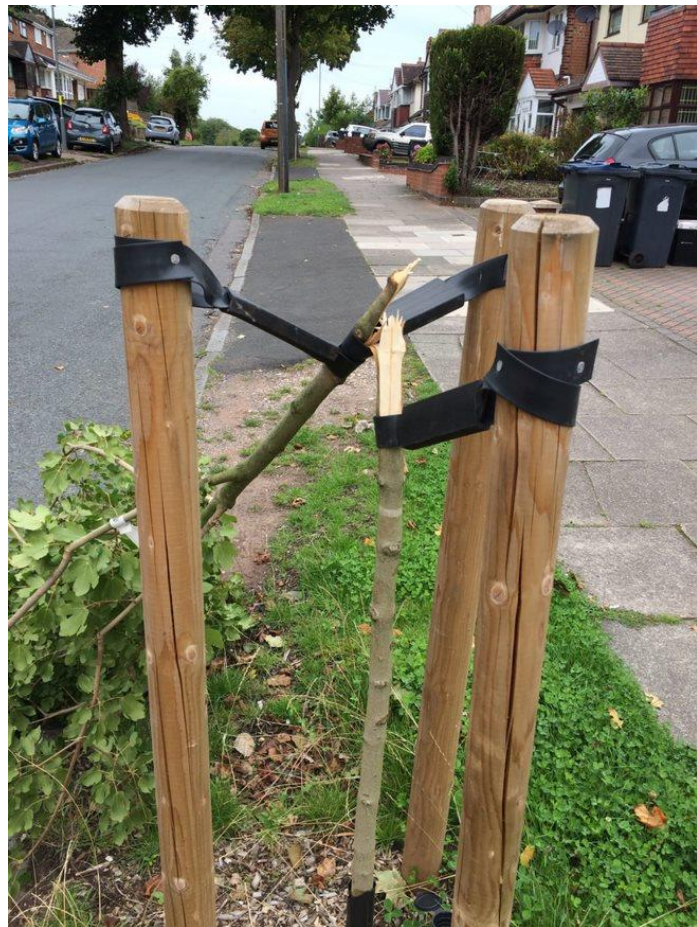
Findings – stakes and vandalism

- 79 were noted as having stakes still on at 5 years and needing removal - 10%
- 14 trees were commented on as being vandalised – either snapped off or ring barked
- Tree surveyors often cut the ties to release the trunk but left the stakes which act as a barrier against cars

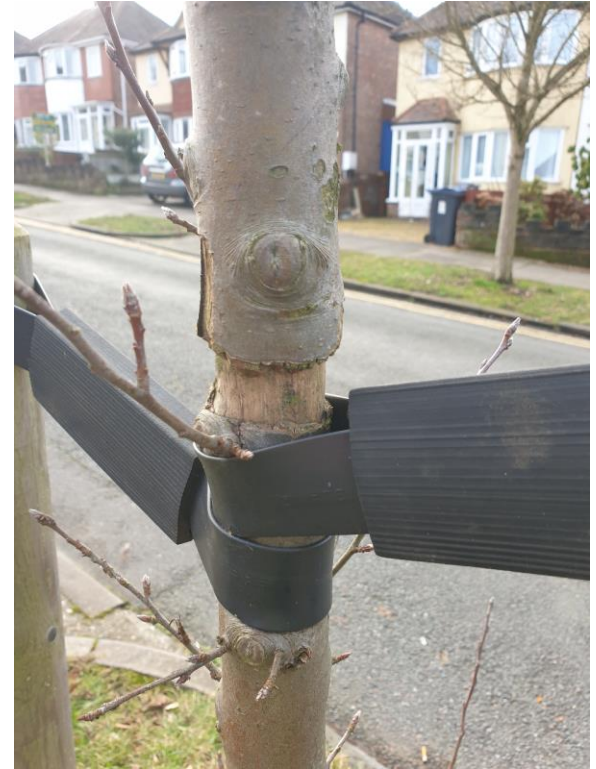
Vandalism

- The tree outside of the house was ring barked which may have been done by the residents as they had just extended the width of their drive and the tree was now in the way.
