Newly Planted Street Survey

Assessing the condition of Birmingham's newly planted trees

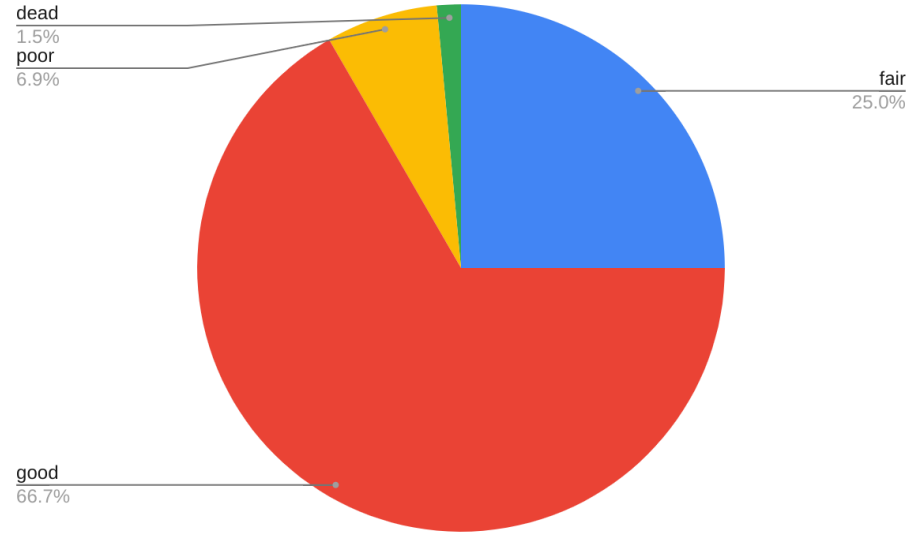
Loose trees

- The soil volumes for wobbly trees varied from 0.26m^3 to 1000m^3 depending on the planting location. Crataegus and Liquidambar were wobbly even in large soil volumes. (assumed depth of 0.4m)
- Looking at all trees, there were 204 planted in less than 1m^3 of soil, and more of these were fair than the overall population.
